Inspection Report

Older Home Sample

Property Address:
123 Older Home Lane
Charlotte, NC 28201

King Construction, Inc dba Inspector Paul

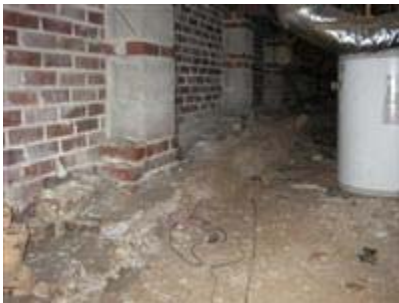
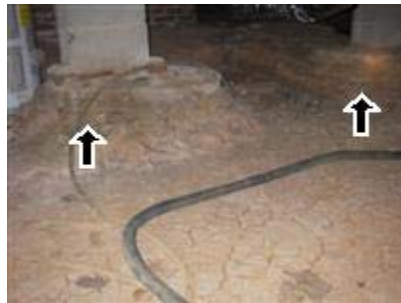
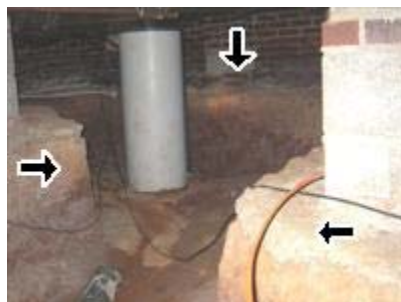
1.0 Earth in much of the crawlspace has been dug out and removed up to the piers and walls. This can effect the integrity of the footings. Recommend a professional engineer evaluate further and repairs per their design.

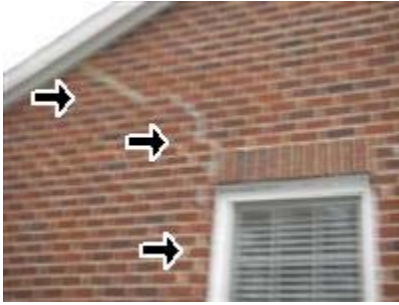
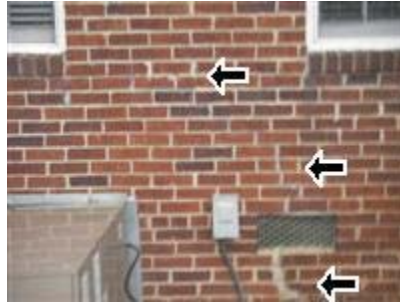
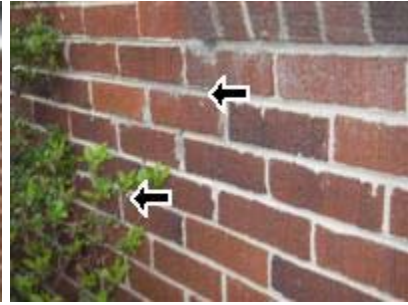
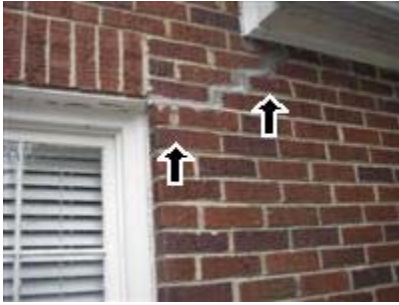
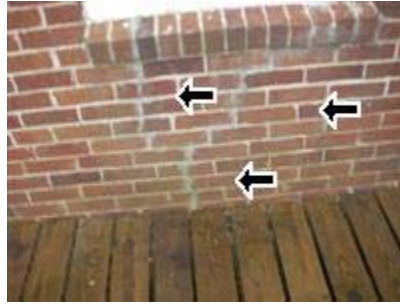
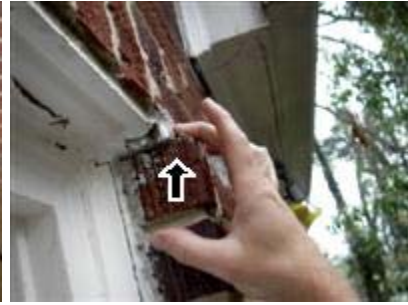
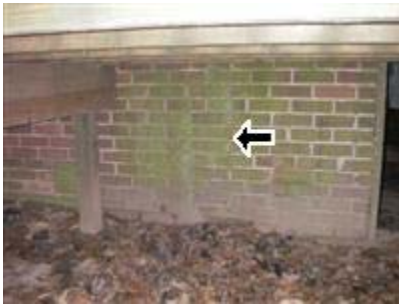
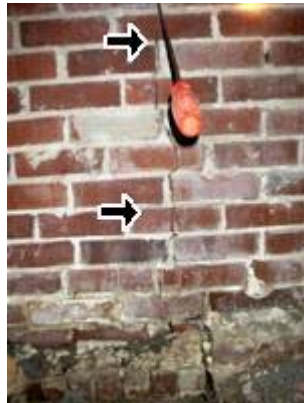
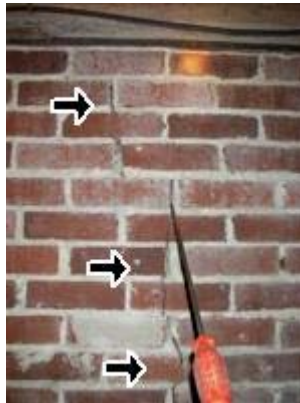
1.1 Inspected a stair step crack on the rear of the home that runs from the ground (in two locations) through a window frame, and up to the eave. Inspected a stair step crack on the right side of the home that runs from the ground (under the deck) through the window and up to the eave. Evidence

suggests the wall has shifted outward. Recommend further evaluation by a professional engineer and repairs per their design.

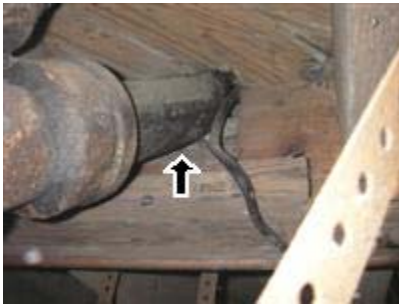
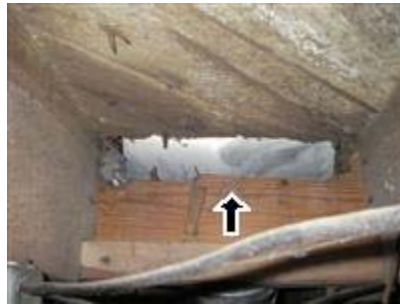
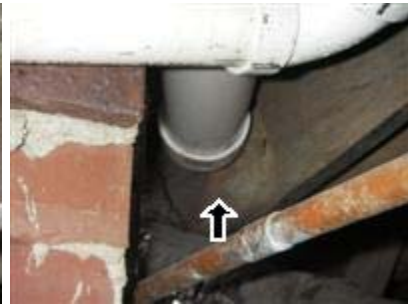
1.3 Doubled floor joist under the right side bath has been notched excessively in two locations by tradesman. Joist under the left side bath has been notched excessively by a tradesman. Repairs are needed. Recommend further evaluation and repair as needed by a qualified licensed general contractor.

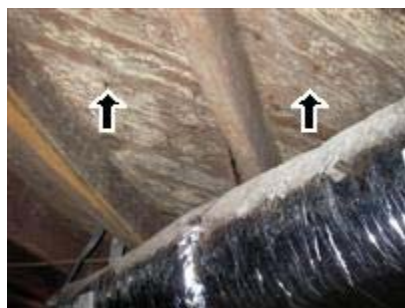
1.3 Picture 4

Signs of mold is present on floor system in crawlspace in several areas. We did not inspect, test or determine if this mold is or is not a health hazard. The underlying cause is moisture. We will take sample of the substances or perform a mold inspection for an additional fee. Recommend further investigation and remediation as needed by a qualified licensed general contractor with a credible mold certification.

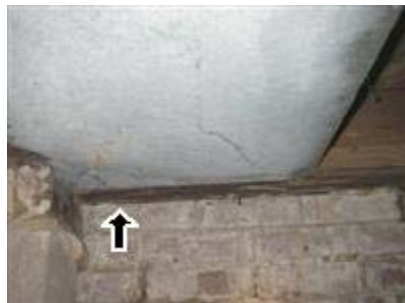
1.3 Picture 5

Sill under the kitchen door is deteriorated. Repairs are needed. Recommend further evaluation and repair as needed by a qualified licensed general contractor.

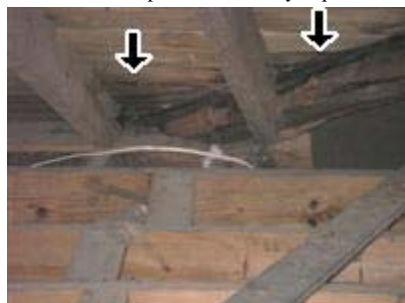
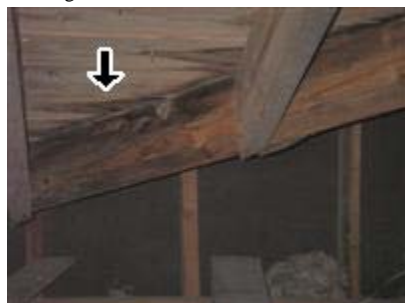
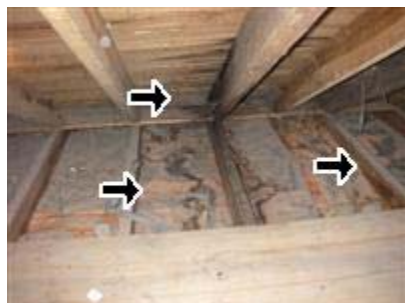
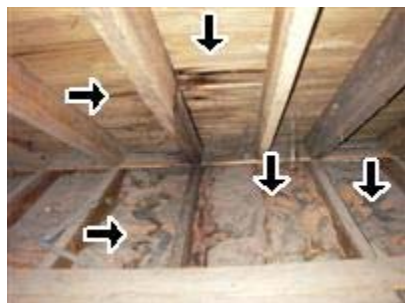
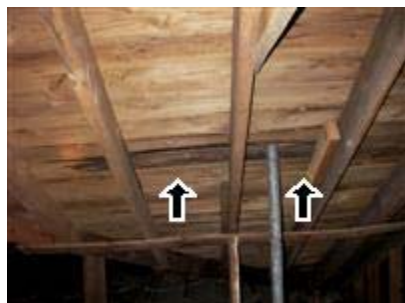
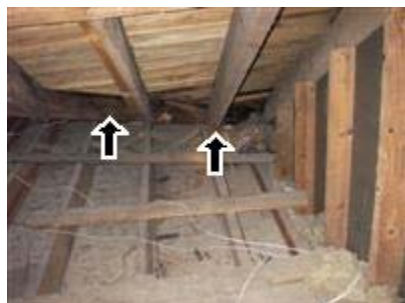
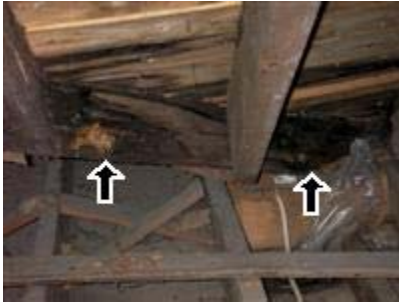
1.5 Water stains from roof leaks were inspected in the valley on the rear right side of the home, on the front of the home above the front door area, and around a plumbing vent pipe on the rear of the home. Evidence suggests the valley rafter at the area of the leak is deteriorated. Recommend further evaluation and repair as needed by a qualified licensed general contractor.

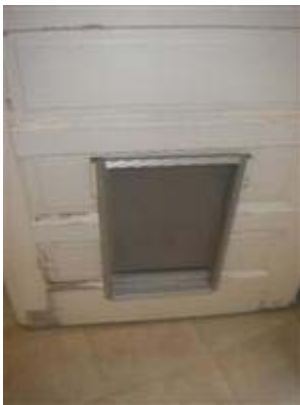
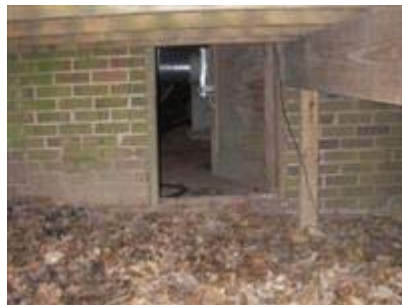
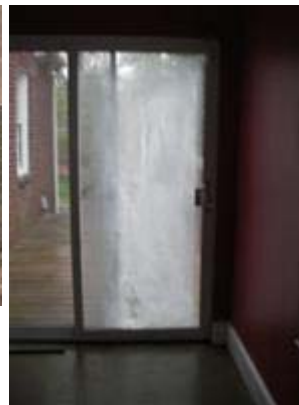
2.1 Sliding door at the sunroom is cloudy/lost seal. Door at the kitchen has a pet access door installed. Crawlspace door will not stay closed, recommend repair to keep out animals. Recommend further evaluation and repair as needed by a qualified licensed general contractor.

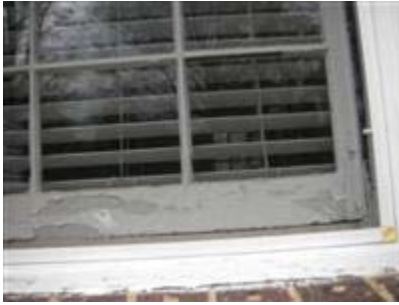
2.2 Picture 1

2.2 Peeling paint, bare wood, and missing glazing at the exterior windows, repairs are needed to prevent deterioration. Recommend further evaluation and repair as needed by a qualified licensed general contractor.

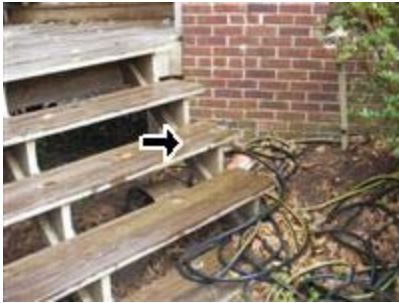
2.4 Picture 1

2.4 Stairs at the rear deck should have a handrail installed on both sides for safety. Recommend further evaluation and repair as needed by a qualified licensed general contractor.

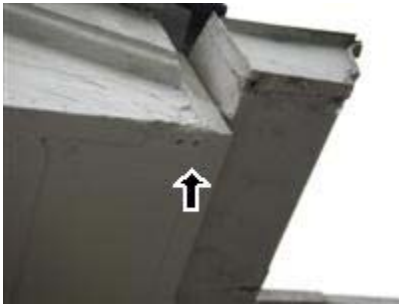
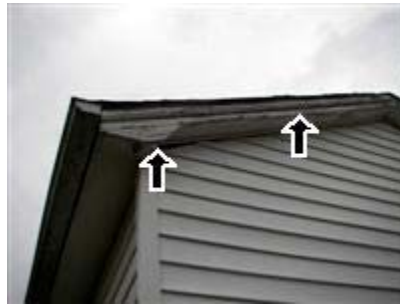
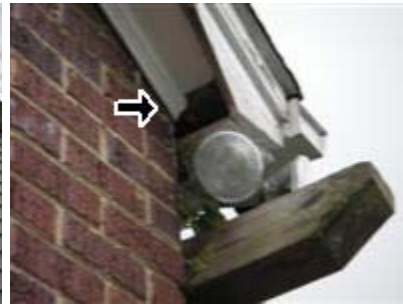
2.6 Bare wood and peeling paint at the eaves, soffits and fascia needs prep, prime, and paint to prevent deterioration. Deteriorated eave on the front of the home at the right corner of the covered porch has been repaired with putty/caulk. Section of eave on the rear of the home, near the driveway, is missing wood this can allow pests/animals into the attic. Recommend further evaluation and repair as needed by a qualified licensed general contractor.

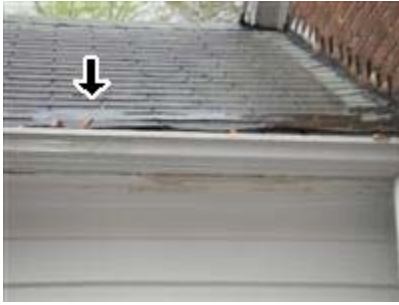
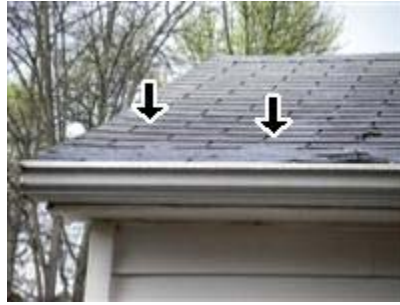
3.0 Roof shingles are nearing the end of its life cycle and has been covered with tar at rear of home (over the sunroom). Due to a lack of recent rain we could not determine if the leaks have been corrected. Recommend a qualified licensed general contractor inspect and repair as needed.

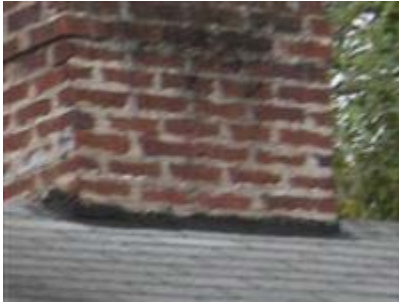
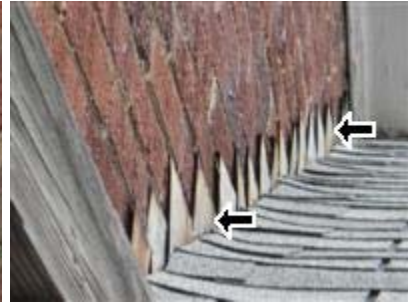
3.1 Chimney is not flashed properly. Chimney has been tarred around base. This area will need periodical maintenance. Recommend further evaluation and repair or replace as needed by a qualified licensed general contractor. Cap flashing at the roof sections over the porch and kitchen are not set back into the brick/mortar. Leaks can develop at the seams. Recommend further evaluation and repair or replace as needed by a qualified licensed general contractor.

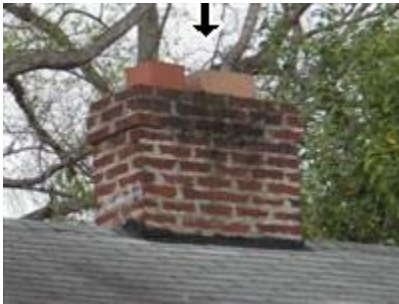
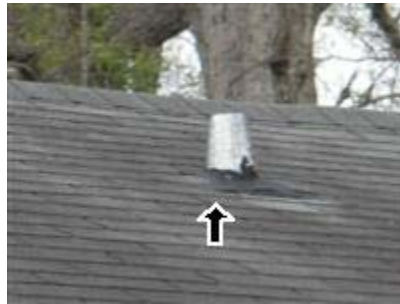
3.2 Recommend installing a rain cap on the chimney to prevent water and animal intrusion. A cone shaped home made metal plumbing boot is installed above the roof line on the front of the home, recommend replacing with a standard boot to prevent leaks. Recommend further evaluation and repair as needed by a qualified licensed general contractor.

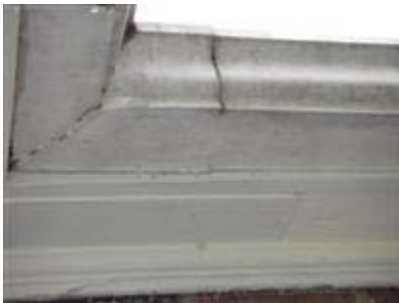
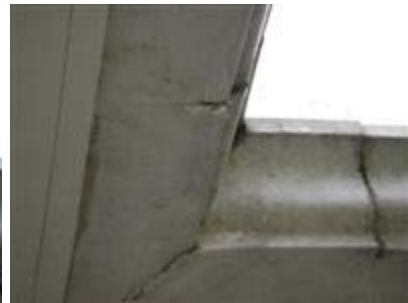
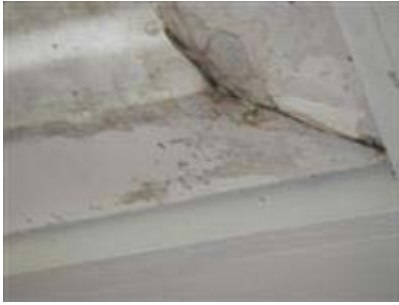
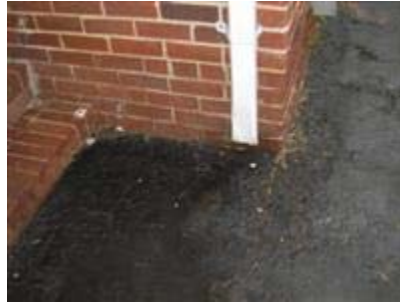
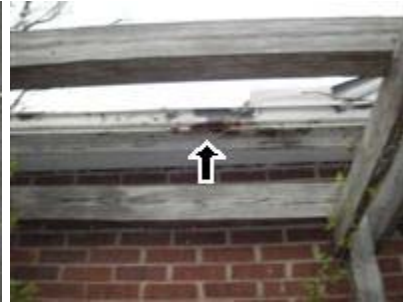
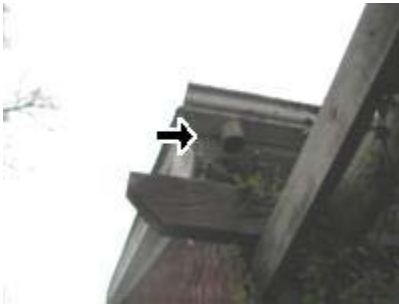
3.3 Gutter leaks at seam (s), are clogged, rusted, needs cleaning of debris, and has missing and loose downspouts at virtually all areas where gutters are installed. Gutters that drain poorly or clogged can lead to many costly problems such as deterioration of fascia, soffit or roof edge. It can also cause gutters to pull loose and lead to possible water intrusion. Recommend a qualified licensed general contractor inspect and repair as needed.

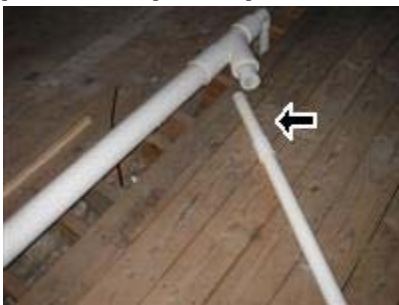
4.0 Picture 1

4.0 Toilet is loose at floor and run continuously in the right hall bath. Repairs are needed to prevent the toilet from leaking, a new wax seal may be needed. Stopper at the jetted tub does not function (we could not fill the tub and check the jets for proper operation). Recommend a qualified licensed plumber repair or correct as needed. Plumbing vent pipe is disconnected in the attic this can allow sewer gasses to vent into the attic. Recommend a qualified licensed plumber repair or correct as needed.

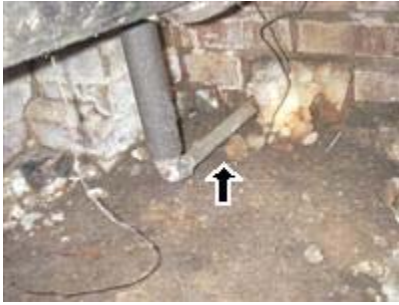
4.1 Picture 1

4.1 Old galvanized supply line will rust from the inside and most likely need replacement in the near future from the meter to the crawlspace. We could not determine if the buried pipe has rusted to the point where replacement is needed. Recommend a qualified licensed plumber repair or correct as

needed.

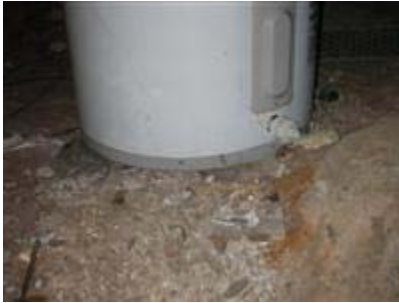
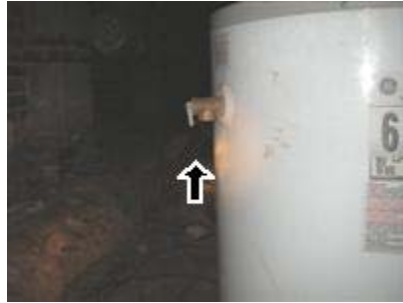
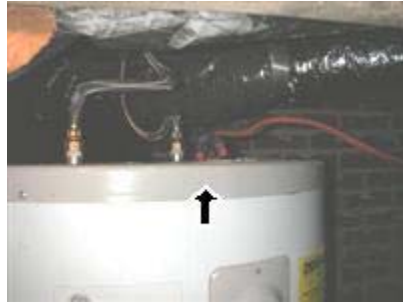
4.2 Water heater is sitting on the ground in the crawlspace, this can lead to rusting at the base. Water heater T&P valve needs a 3/4" pipe installed to within 6" of the ground for safety. Recommend further evaluation and repair as needed by a qualified licensed plumbing contractor. Wiring for water heater was spliced outside of panel. Electrical issues are considered a hazard until repaired. Recommend a licensed electrician correct as necessary.

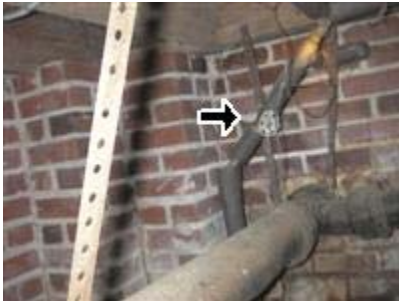
4.3 Picture 1

4.3 The main shut off is the knob located underneath in crawlspace. This is for your information.

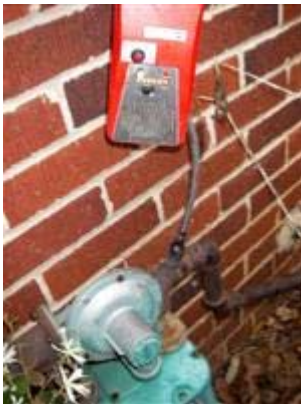
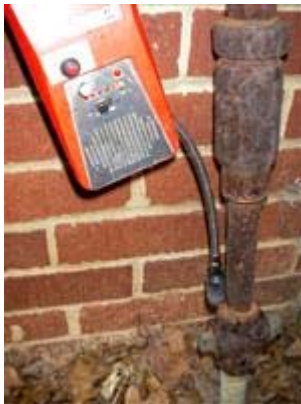
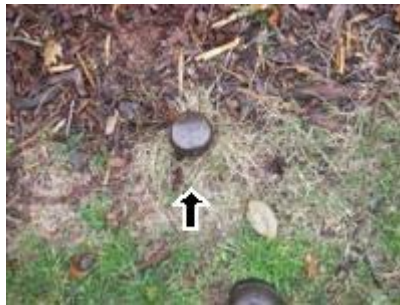
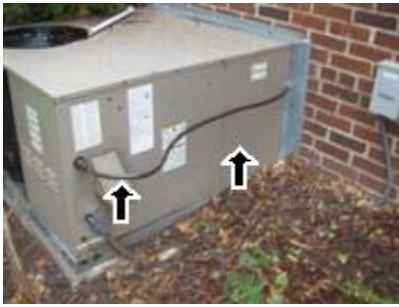
4.4 Gas Tracer (device) indicated several leaks at meter outside. This is a safety issue and should be repaired. Recommend a qualified professional from the gas company or licensed plumber who is certified in gas line installation and repair inspect further and repair as needed. Evidence suggests an oil barrel remains in ground. We did not inspect condition of barrel or soil. Recommend a qualified licensed UST company inspect further and correct as needed. Gas piping to the gas pack does not have an on/off valve or a drip leg installed. Recommend a qualified professional from the gas company or licensed plumber who is certified in gas line installation and repair inspect further and repair as needed.

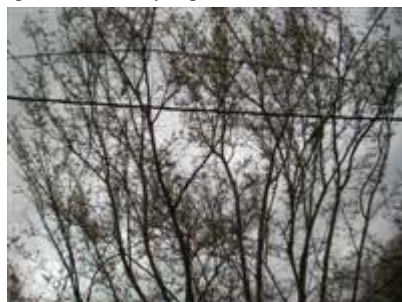
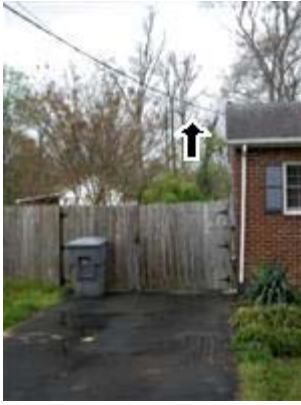
5.0 Electrical service conductors clearance (outside) from driveway may be lower than 15 feet, runs through a tree, and needs correcting for safety. Recommend further evaluation and repair as needed by a qualified licensed electrical contractor.

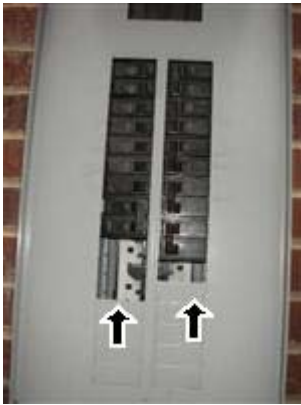
5.1 Picture 1

5.1 Problem(s) discovered in panel such as Knock-outs missing on panel, Improper size/gauge wiring, and breakers are poorly marked and any other problems that an electrician may discover while performing repairs need correcting. Recommend a licensed electrician inspect further and correct as needed.

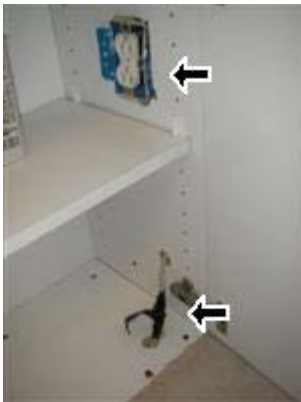
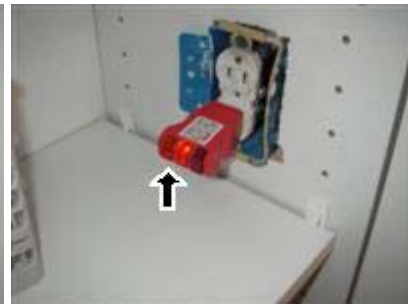
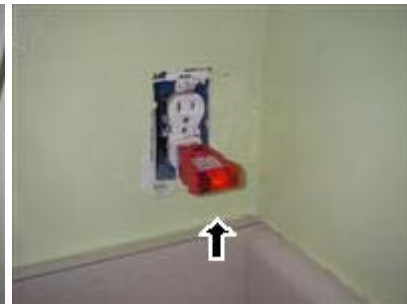
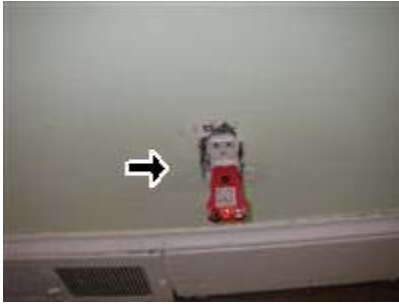
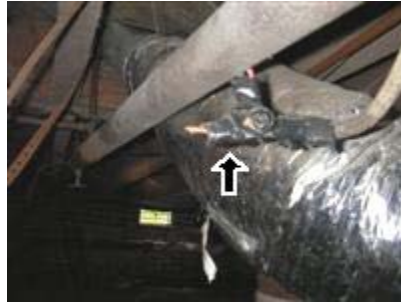
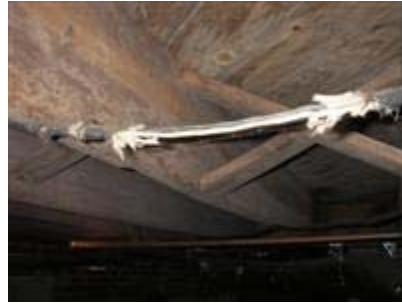
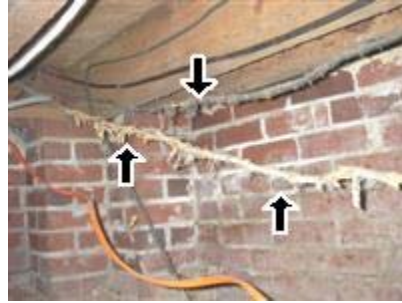
5.3 Inspected a spliced electrical line in the kitchen cabinet. Outlets missing coverplates are unsafe. All there pronged electrical outlets in the home have open ground lines. Exterior light at the kitchen door does not respond to operating controls. Ceiling fan in the sunroom wobbles/out of balance. Light in the laundry closet did not respond to operating controls. Located several electrical lines in the crawlspace that are spliced improperly and/or the sheathing is deteriorated or the line is dangling loose including beside the water heater, along the front of the home, under the kitchen area. All electrical issues should be considered safety hazards. Recommend further evaluation and repair as needed by a qualified licensed electrical contractor.

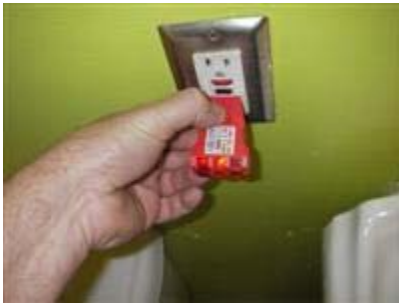
5.5 Picture 1

5.5 GFCI (Ground Fault Circuit Interrupter) outlet at left side bath wont "Trip" when tested. Electrical issues are considered a hazard until repaired. Recommend a qualified licensed electrician inspect further and correct as needed

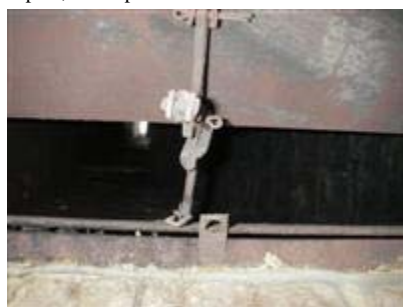
6.2 Picture 1

6.2 Fireplace flue was dirty with creosote and could not be fully inspected. The National Fire Protection Association recommends cleaning and a level 2 inspection of all fireplaces, this is beyond the scope of a home inspectors capabilities. Recommend a qualified reputable certified chimney guild clean, inspect, and repair as needed.

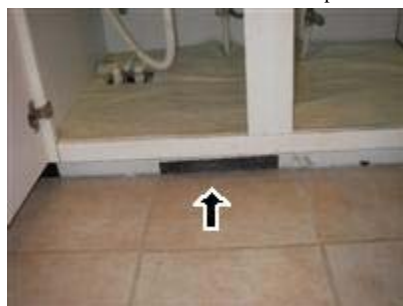
6.4 Picture 1

6.4 HVAC supply in the kitchen vents into the underside of the sink base. Some air flows into the kitchen and some flows into the sink base. Recommend further evaluation and repair as needed by a qualified licensed HVAC contractor.

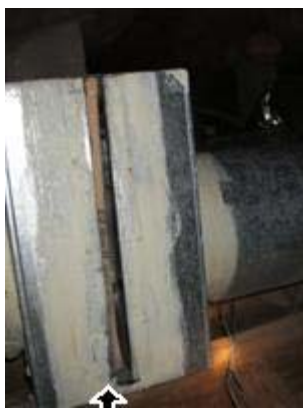
6.4 Picture 2

Filter is located in the crawlspace and is missing a cover to seal the system(see photo) Recommend further evaluation and repair as needed by a qualified licensed HVAC contractor.

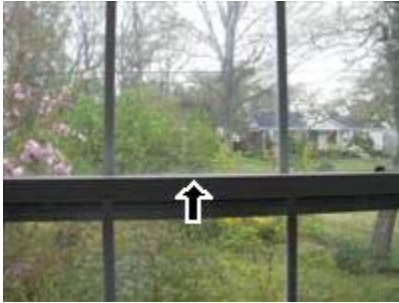
8.6 Picture 1

8.6 Several of the single pane windows throughout the home are stuck/painted shut. This is a fire safety hazard and should be corrected. Window on the front wall in the sunroom has no lock hardware. Recommend further evaluation and repair as needed by a qualified licensed general contractor.

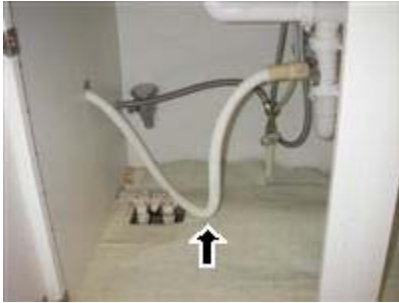
10.0 Picture 1

10.0 Dishwasher drain hose did not perform a loop to create a trap under sink. A back up in the kitchen drain could fill the dishwasher with water. Recommend further evaluation and repair as needed by a qualified licensed appliance repair company.
