Inspection Report

Older Home Sample

Property Address:
123 Older Home Lane
Charlotte, NC 28201

King Construction, Inc dba Inspector Paul

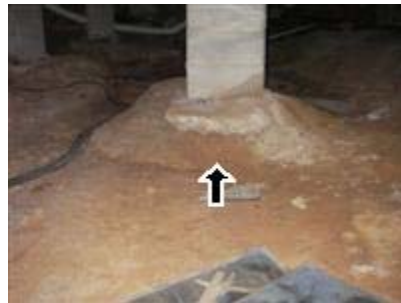
1.0 Picture 3

1.0 Earth in much of the crawlspace has been dug out and removed up to the piers and walls. This can effect the integrity of the footings. Recommend a professional engineer evaluate further and repairs per their design.

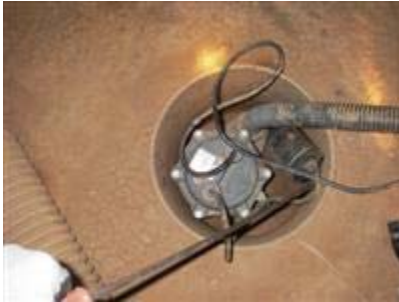
4.5 Picture 1

4.5 Sump; pump was not plugged in, could not be inspected.
